**Investigation Report on the Accident to**

**Ethiopian 409 – Boeing 737-800**

**Registration ET-ANB**

**Presented by the IIC on 17<sup>th</sup> January 2012**

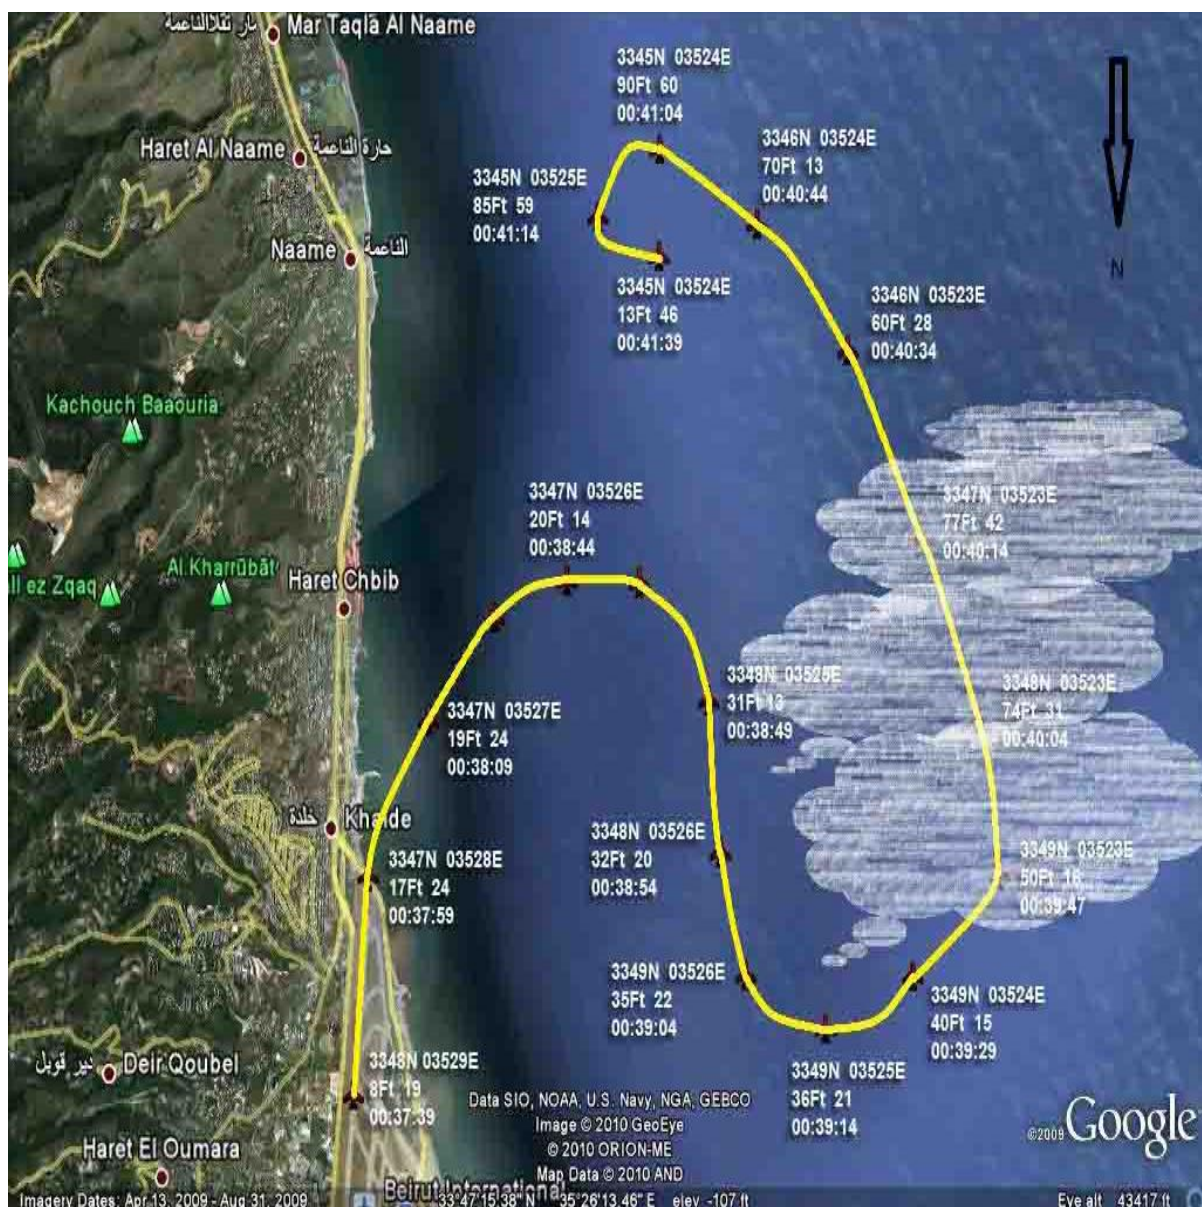
**Figure 11: ET 409 Radar Tracks with cloud information**

Further reconstruction of ET flight path was later on carried out by the Lebanese CAA IT technician in synchronization with the meteorological office at BRHIA and the ATC weather data. This is shown in figure 11 below.

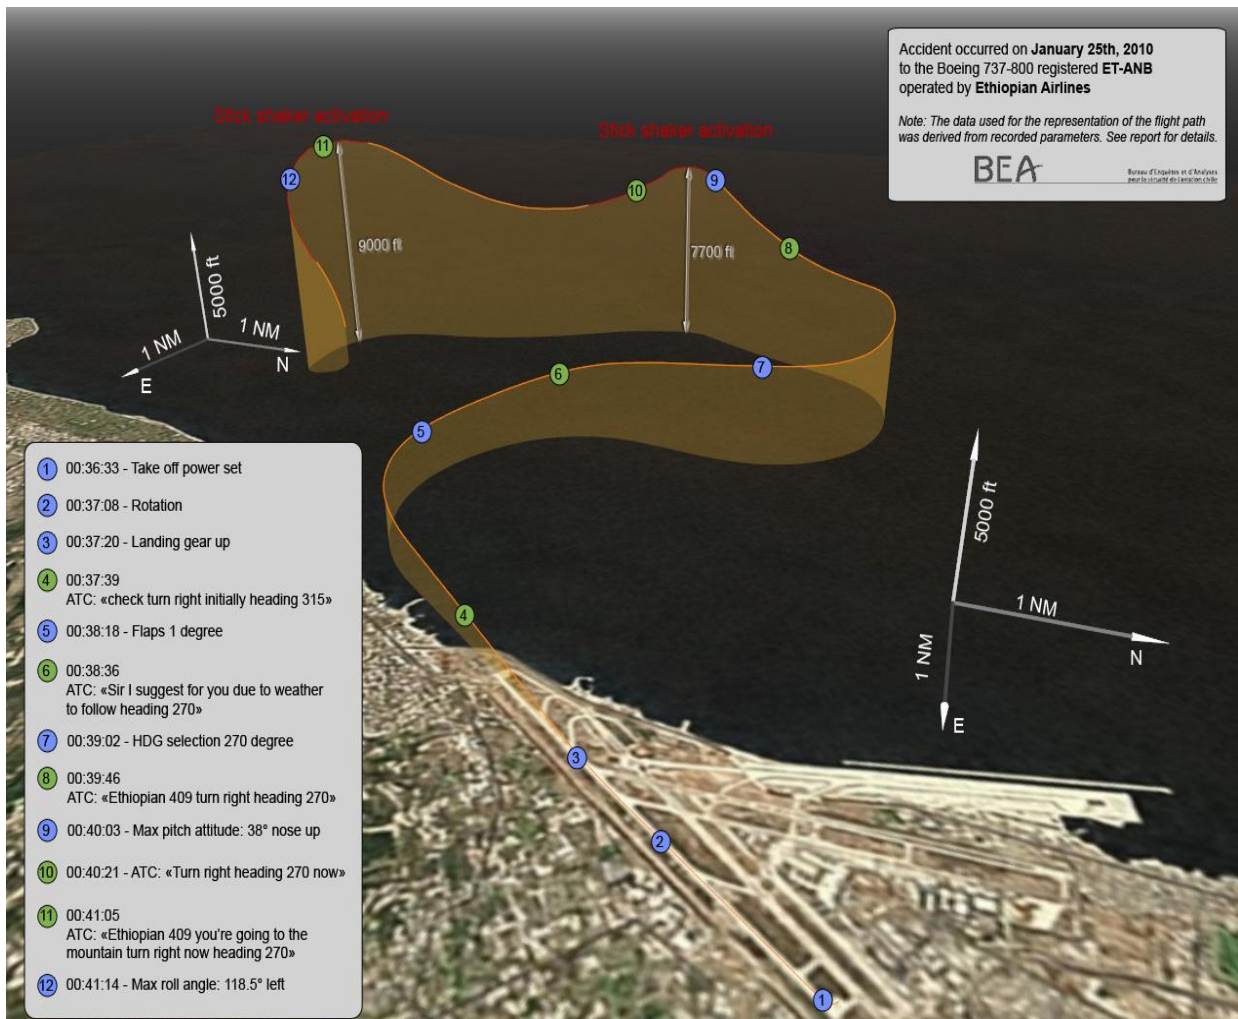
**Figure 12: ET 409 Flight 3 D profile**

A reconstruction of ET horizontal and vertical track were developed by the BEA based on the data retrieved from the DFDR recording. These reconstructions are incorporated as Figure 1 and Figure 2 of this report. The following Figure 12 reproduces in 3D the flight profile associated with the major events points.

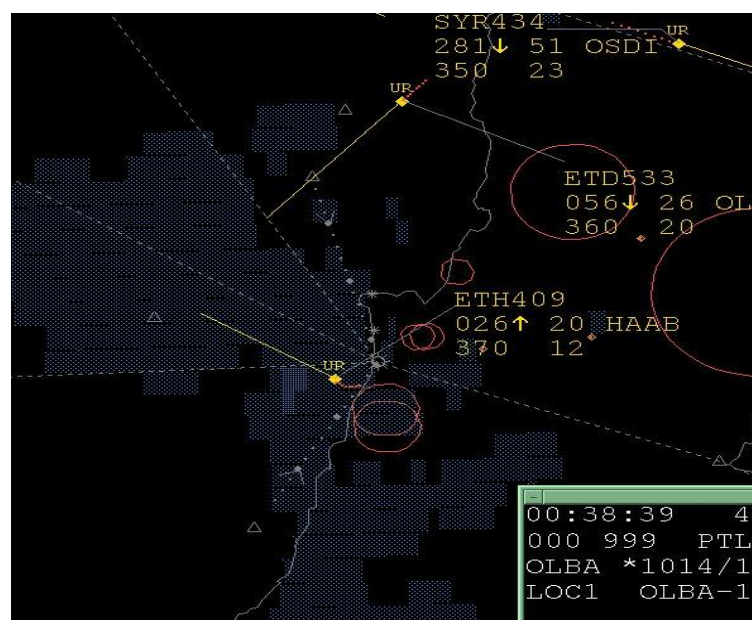
**Figure 15: Radar Snapshot at 00:38:39**

The Area controller was even trying to be more helpful and suggested to ET 409, “*due to weather to follow heading 270° to be in the clear for fifteen miles twenty miles then go to Chekka, and it is up to you just give me the heading*”. Thus, the controller suggested first an avoidance heading to the crew and then left it up to them to choose any other heading they felt comfortable with to avoid weather, as long as they advised him of that heading, since the responsibility for weather avoidance rests with the Flight Crew and their aircraft radar is definitely more accurate than the ATC radar in identifying weather and assessing the associated risks. Figure 15 in that report reproduces the snapshot of the radar picture displayed in front of the controller at the beginning of that transmission.

However, at that same time, the captain was having problems handling the aircraft, he turned beyond the selected/cleared heading despite the FD command and overbanked triggering “bank

*angle*” warnings. That situation might have been preoccupying the crew, and the controller offer most likely added to their workload, since they were concentrating on more serious issues and focusing their attention on what was going on at an aircraft handling level. This could explain why the crew initially misread the heading as 210°. Nevertheless, that situation couldn’t have been known to the controller.

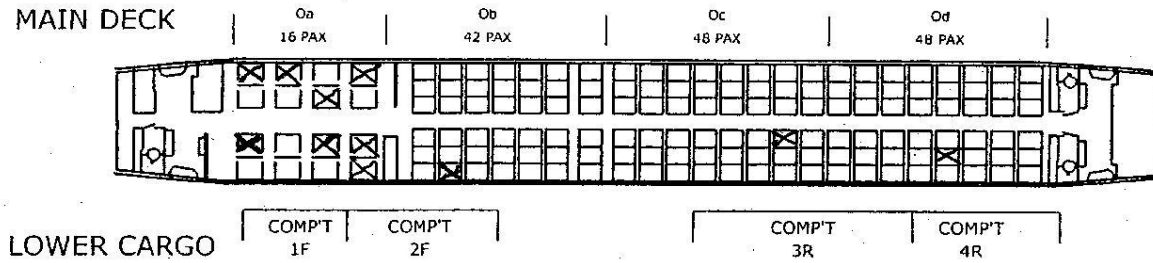
**Figure 18: Airplane Map**

**N.B.** *Seats marked with an X are the seats were of the passengers whose bodies were recovered on day 1. Two out of these passengers were children under 5 years of age.*
